# **The Fukushima Daiichi Nuclear Power Station Accident**

Tomomi Matsunaga

Kansai Electric Power Company

# Accident Description: Fukushima Daiichi NPS

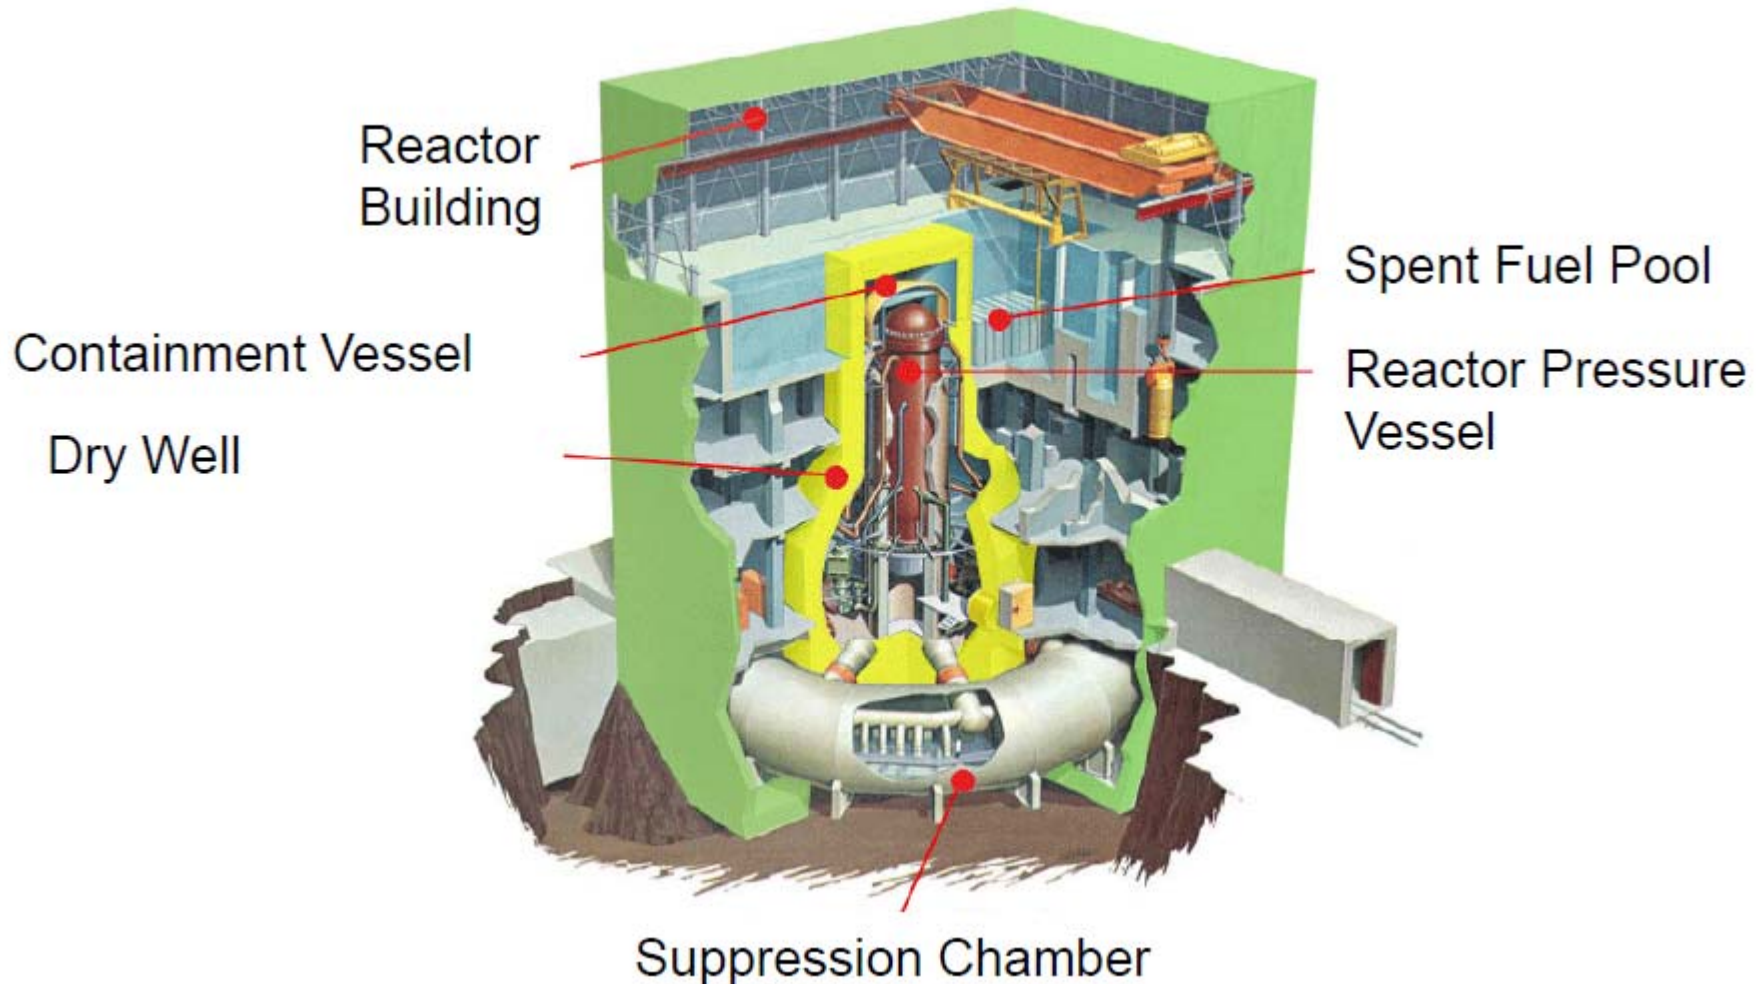
# Overview of Boiling Water Reactor (BWR)

(Mark-I Type ; Fukushima Daiichi Unit 1,2,3,4 and 5)

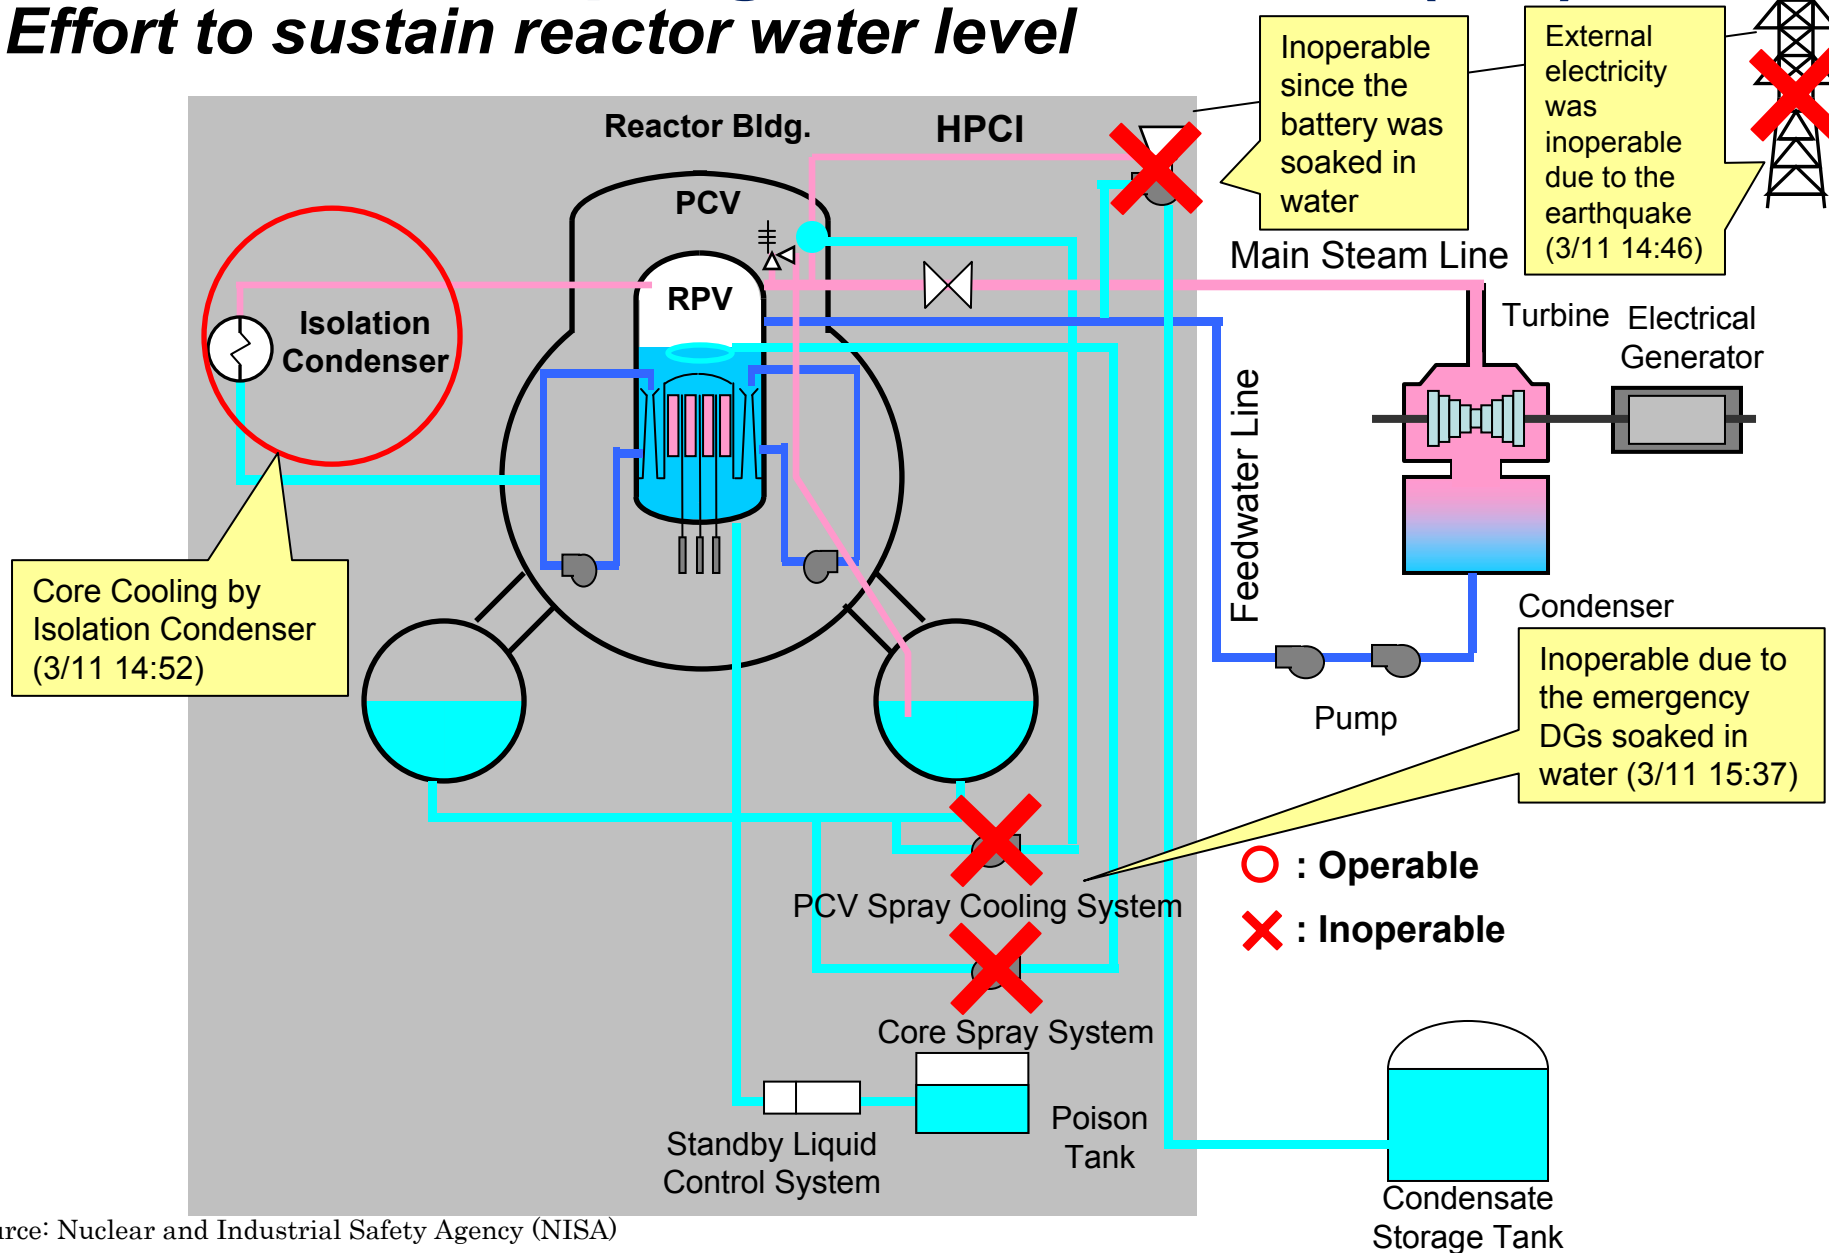
# Accident progression at Unit1(1/3)

## Effort to sustain reactor water level

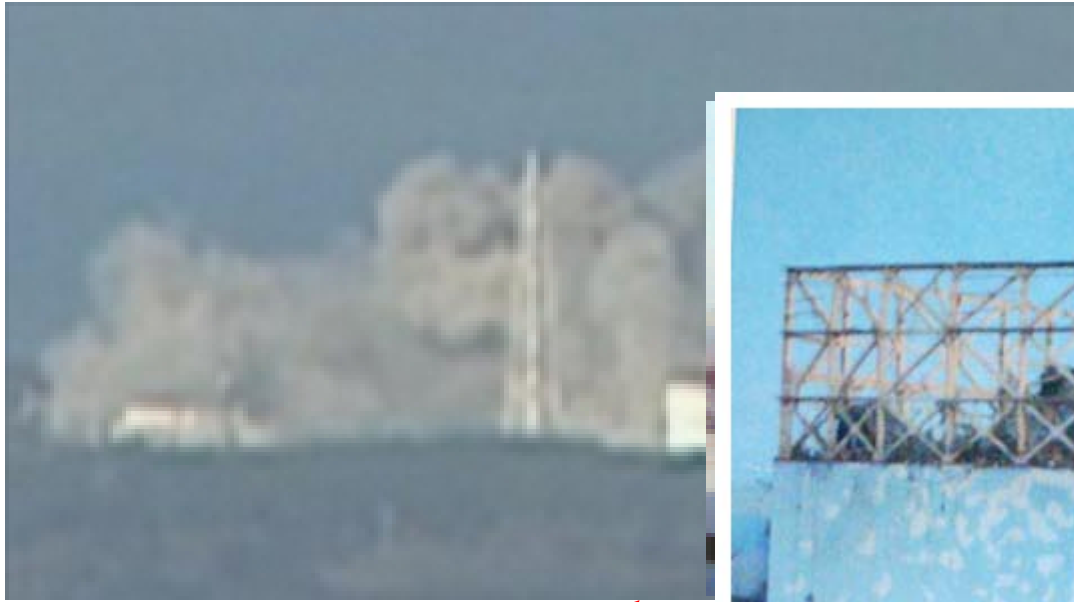
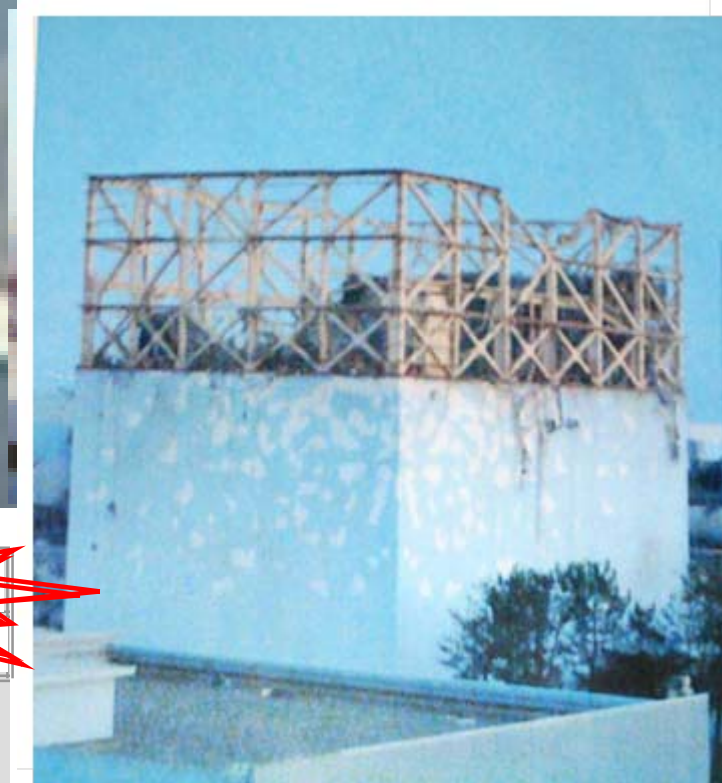
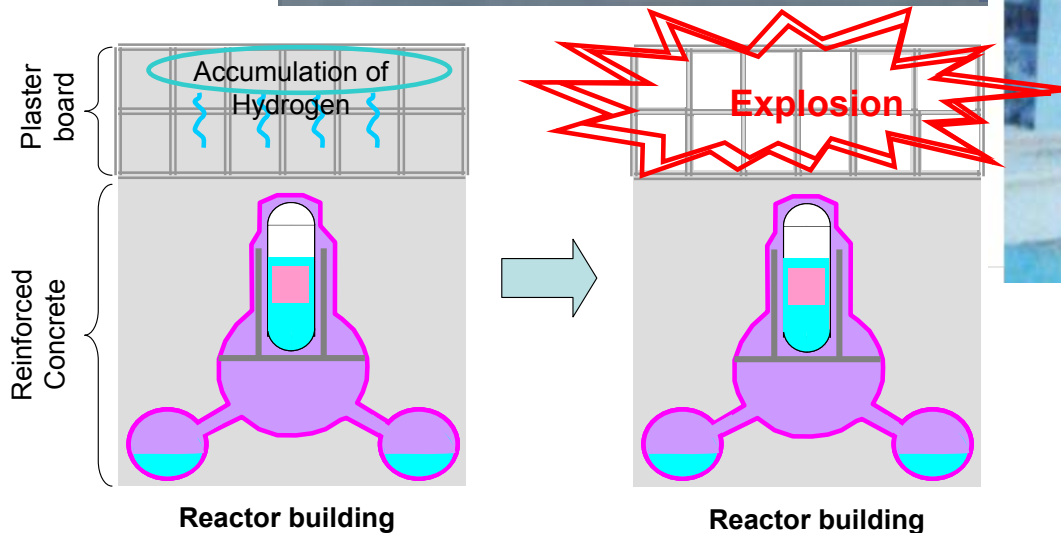
# Accident progression at Unit1(3/3)

## Hydrogen explosion in the operation floor

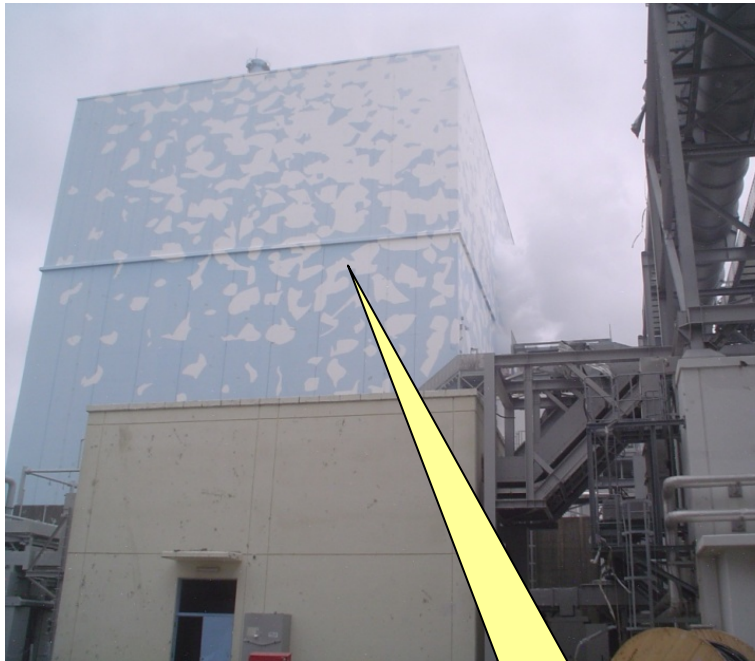
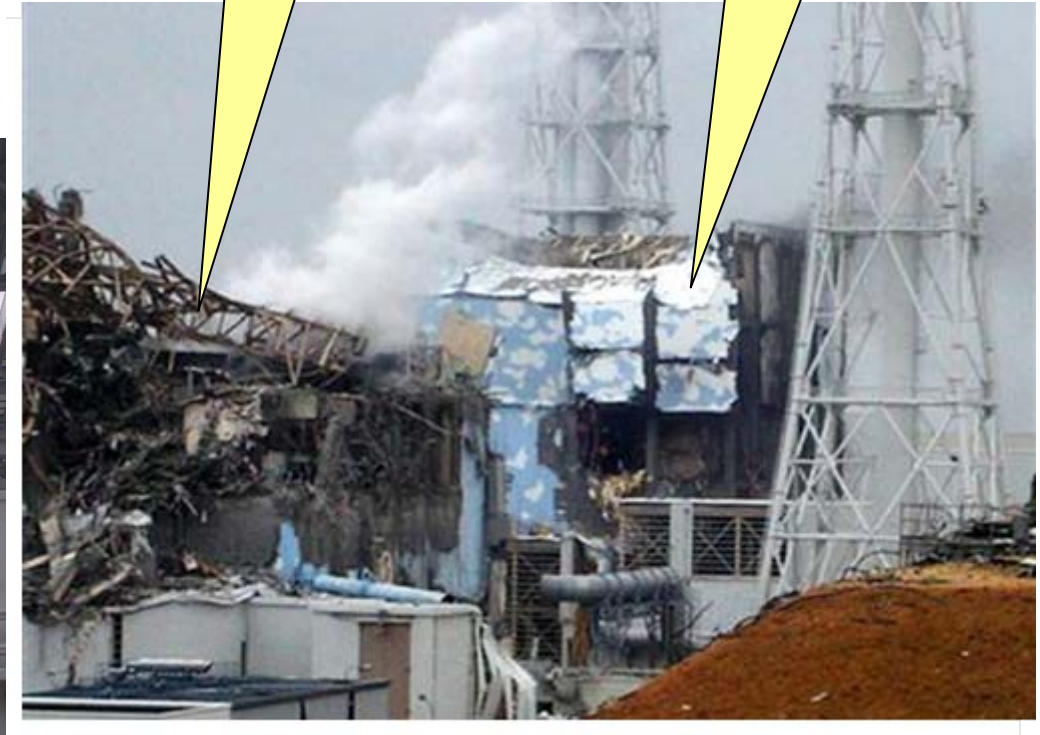
# Accident Progression at Unit 2 through 4

Vapors rising from Unit 3 are assumed to be produced from Spent Fuel Pool.

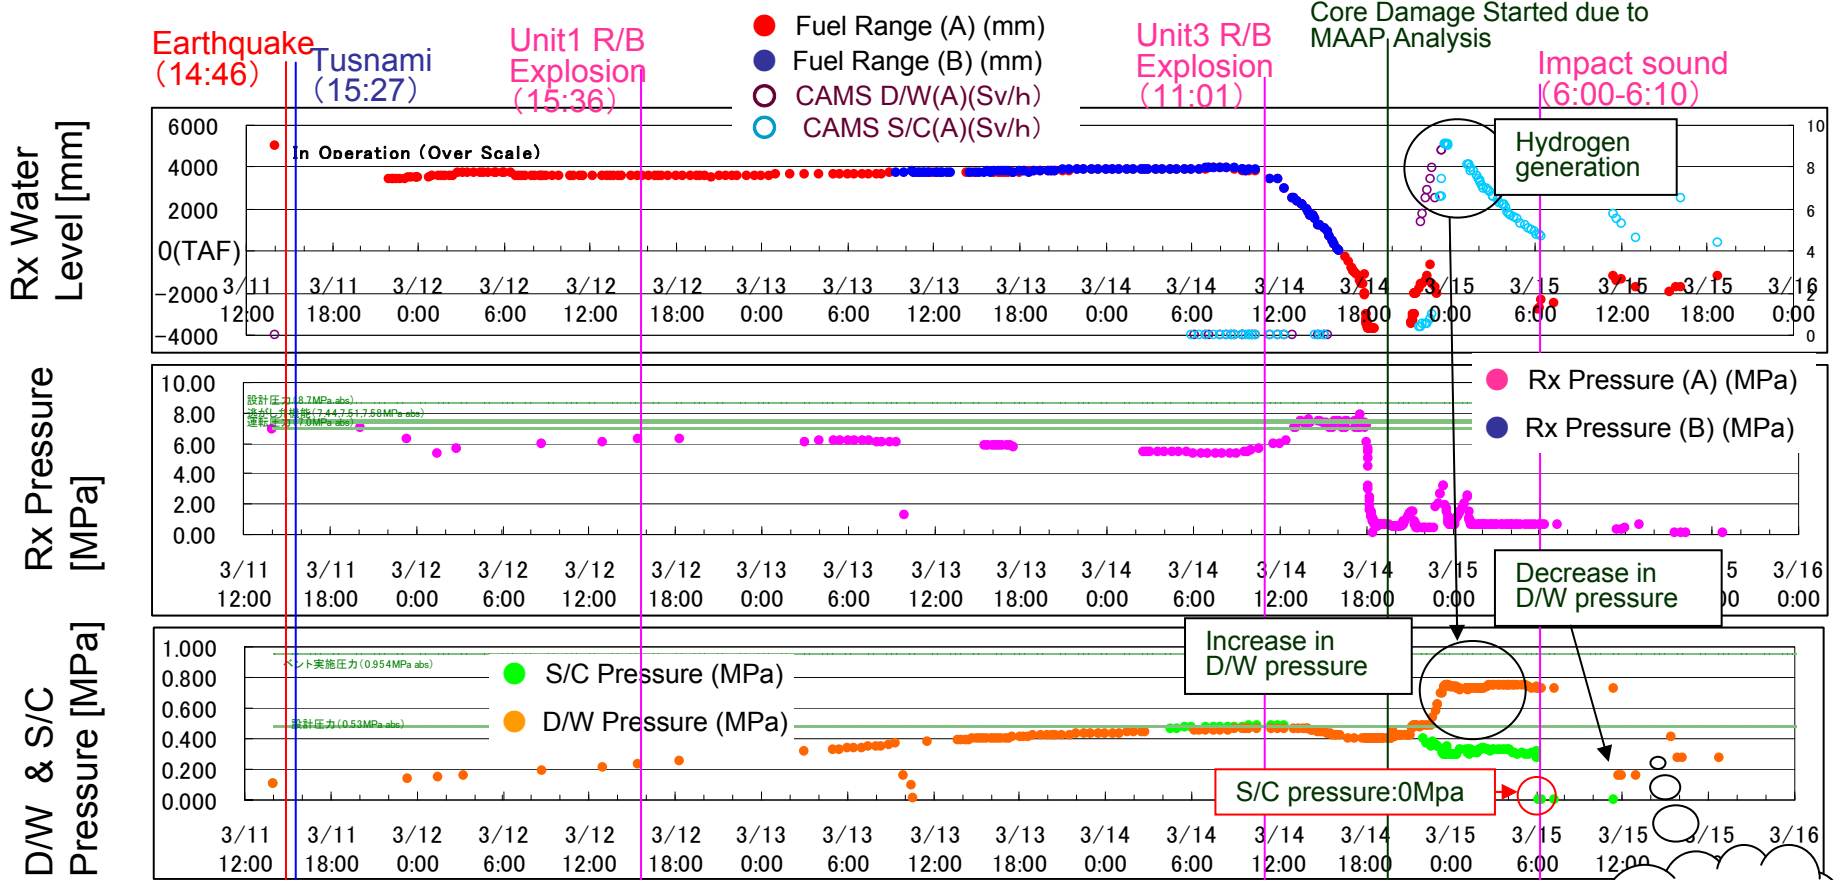
# Fukushima Daiichi Unit 2 Plant Parameter and Operation

RCIC	Operation confirmed (2:55)		Out of Service (13:25)	
HPCI	No Operation		Depressurization	Valve C
SRV			(~18:00)	2 Valves Open
FP/Fire Engine	Order for Sea Water Injection Preparation (12:05)		(19:54)	Sea Water
PCV Vent	Order for Vent Preparation (17:30)	(11:00) Vent Line Configuration Completed	Small Vent Valves Opened

Radioactive gas released into the air

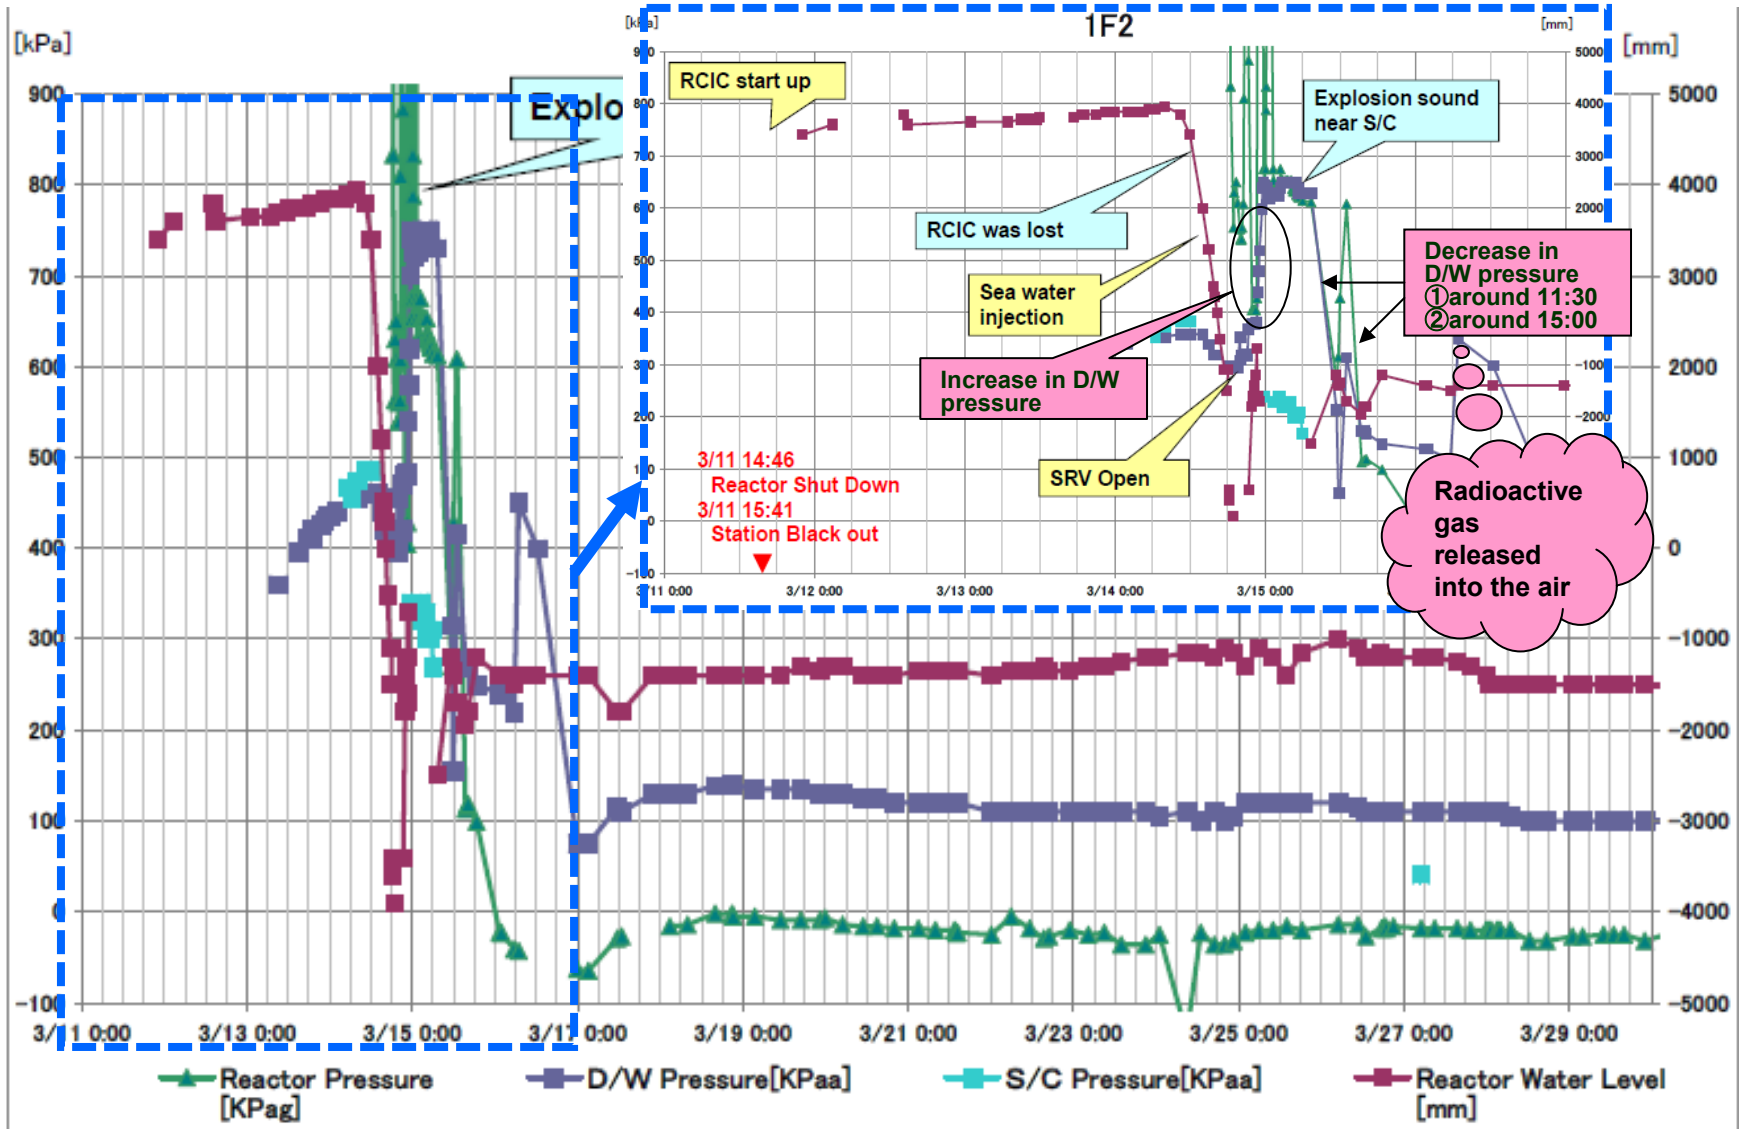
# Plant Parameter: Fukushima Daiichi Unit 2

March 11 ~ March 30, 2011
